TRANSPORTATION RESEARCH CENTER

ON-SITE AIR BAG INVESTIGATION

CASE NO. - 95-17
FLEET - LEASED VEHICLE
LOCATION - TEXAS
ACCIDENT DATE 1995

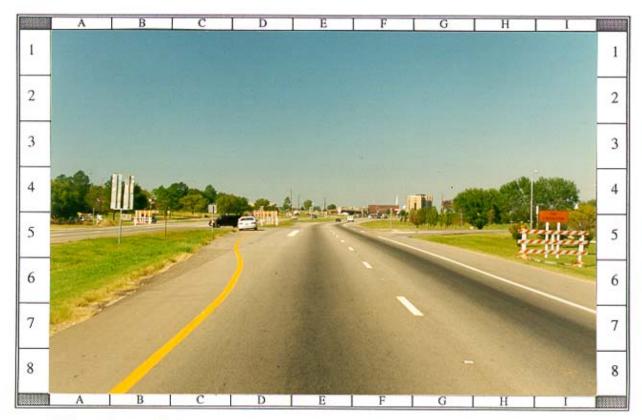
01 -- Case Vehicle's westward travel path in inside through lane approximately 50 meters (165 feet) east of impact

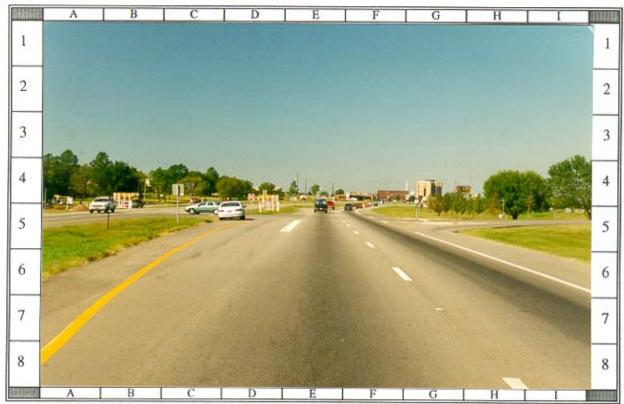
02 -- Case Vehicle's westward travel path in inside through lane approximately 30 meters (99 feet) east of impact

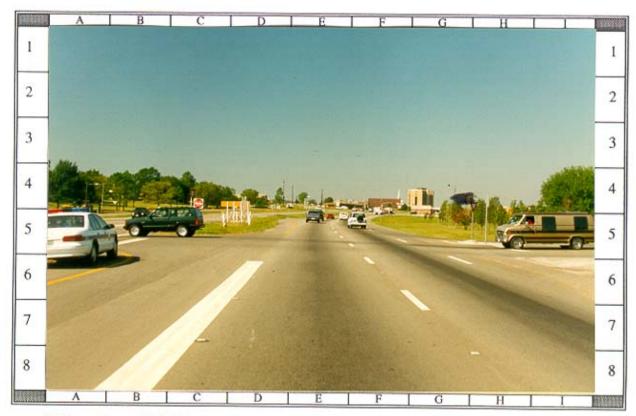
03 -- Case Vehicle's westward travel path in inside through lane approximately 15 meters (50 feet) east of impact

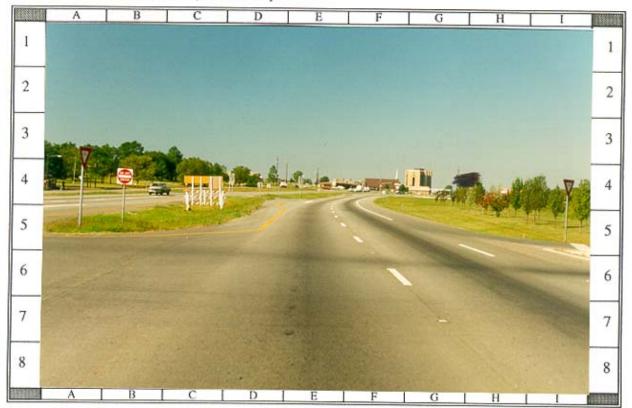
04 - Case Vehicle's westward travel path in inside through lane approximately 3 meters (10 feet) east of impact

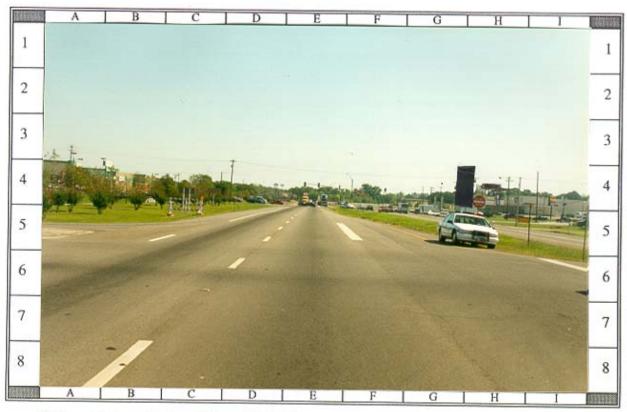
05 -- Eastward view of Case Vehicle's westward travel path in inside through lane from area of impact in intersection

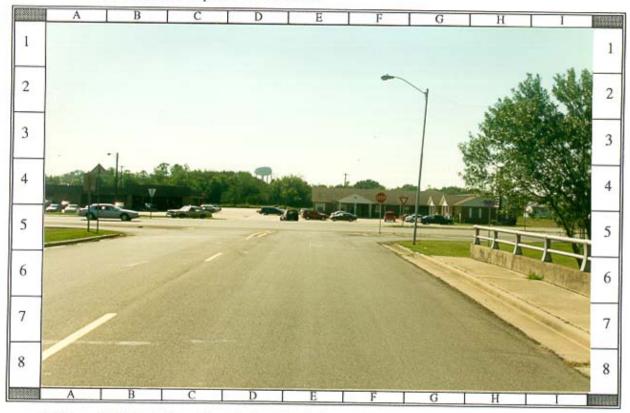
06 - Vehicle #2's southward travel path in southbound lane approximately 50 meters (165 feet) north of impact

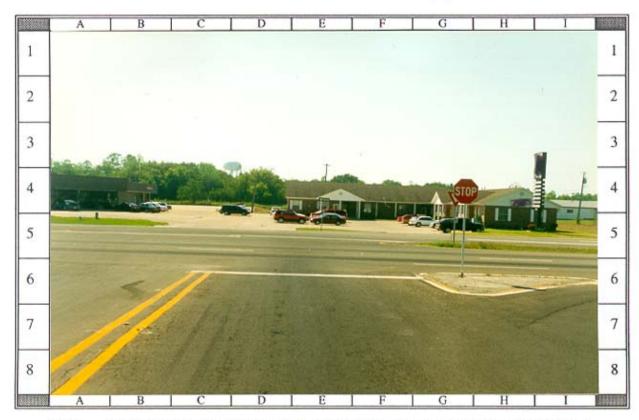
07 -- Vehicle #2's southward travel path in southbound lane approximately 20 meters (66 feet) north of impact

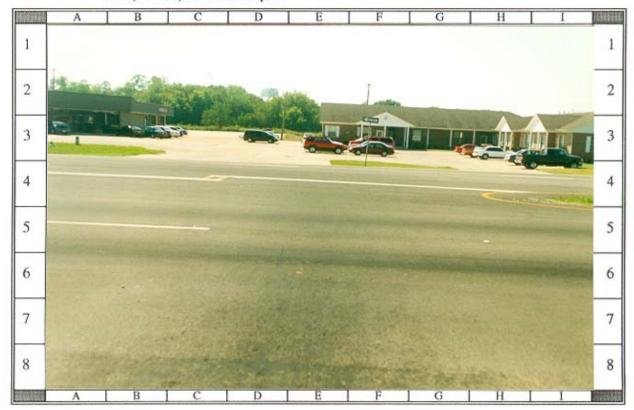
08 -- Vehicle #2's southward travel path in southbound lane approximately 3 meters (10 feet) north of impact

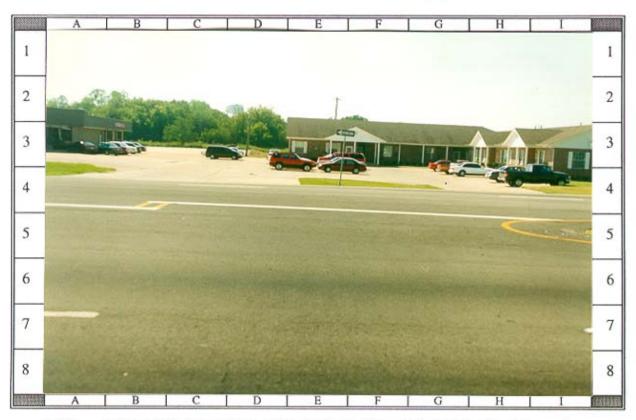
09 -- Vehicle #2's southward travel path in southbound lane just prior to impact

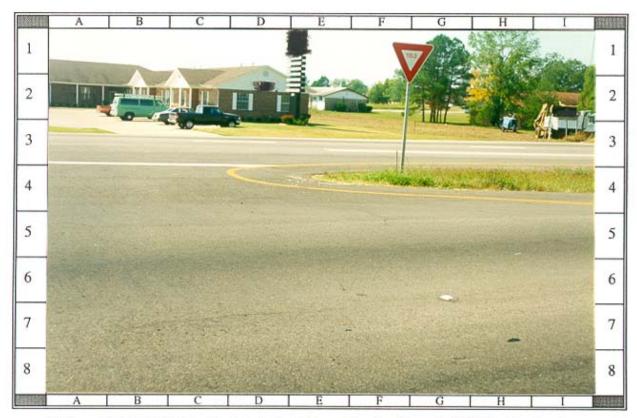
10 - Vehicle #2's southwestward post-impact path of travel; NOTE: final rest position was near center median facing east-southeast

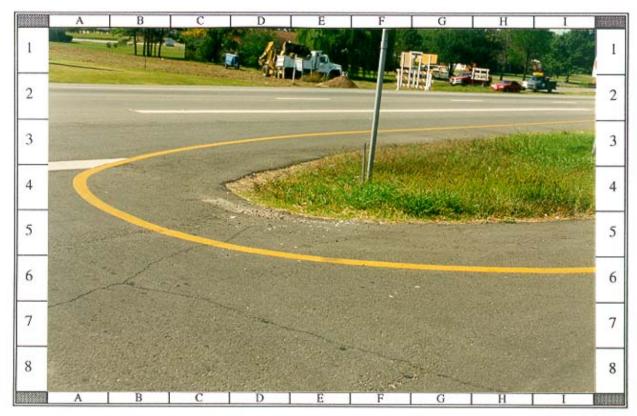
11 -- Vehicle #2's final rest position near center of median heading east-southeast; NOTE: vehicle rotated counterclockwise from impact to rest

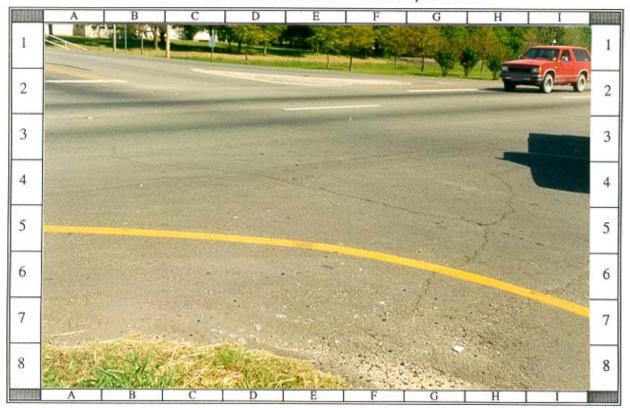
12 -- Northeast view from vehicle #2's final rest position of southward travel path and glass debris near median most likely from driver's window

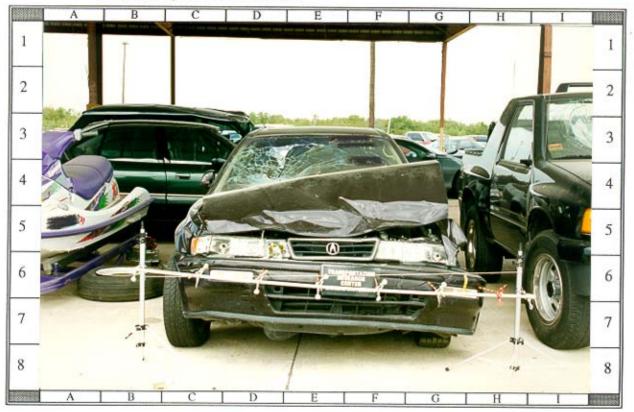
13 -- Case Vehicle's damaged front without contour gauge; NOTE: direct damage is essentially across entire front

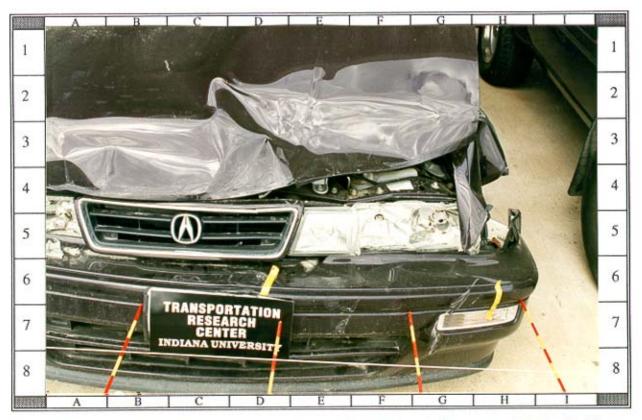
14 - Case Vehicle's damaged front with contour gauge present; NOTE: slight shift of front end to left (toward right edge of photo)

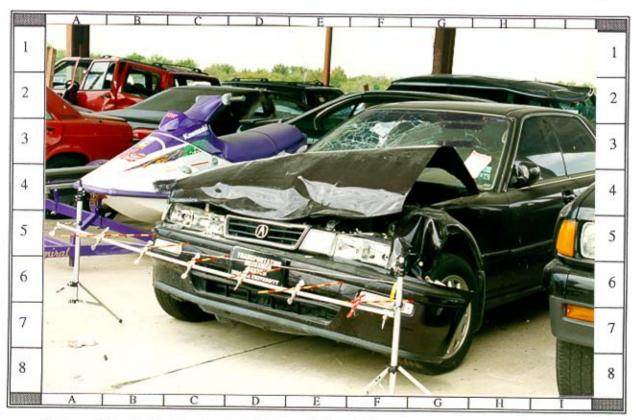
16 -- Overhead view of frontal crush to Case Vehicle with contour gauge present; NOTE: maximum crush occurs @ C₁ (see cell H5)

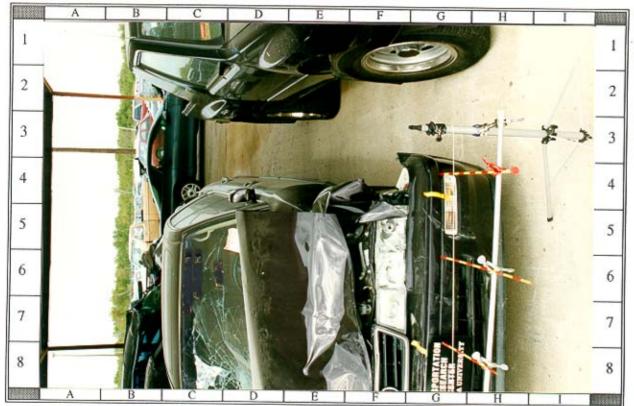
18 -- Reference line view of Case Vehicle's left side from front showing front left corner damage and slight leftward end shift

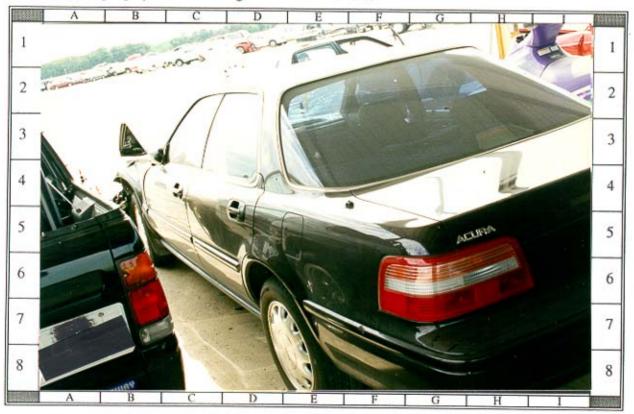
20 -- Case Vehicle's undamaged left side and left rear viewed from approximately 45 degrees left of back

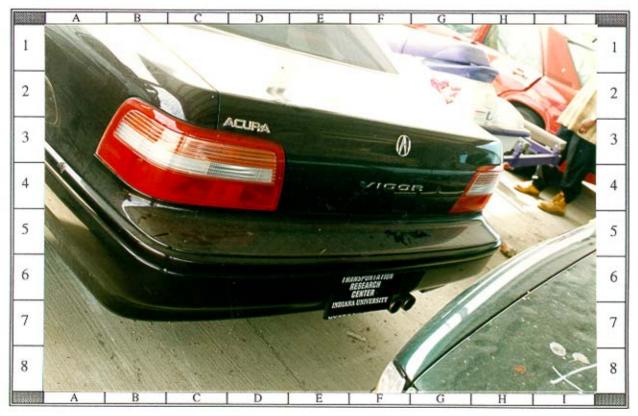
21 -- Case Vehicle's undamaged back viewed from approximately 45 degrees left of back

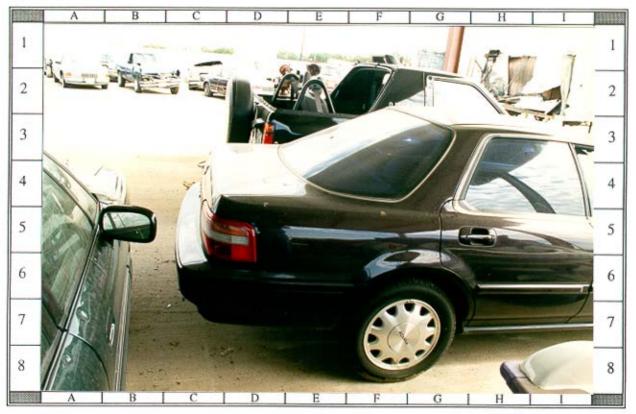
22 -- Reference line view of Case Vehicle's undamaged back from right also showing undamaged right rear

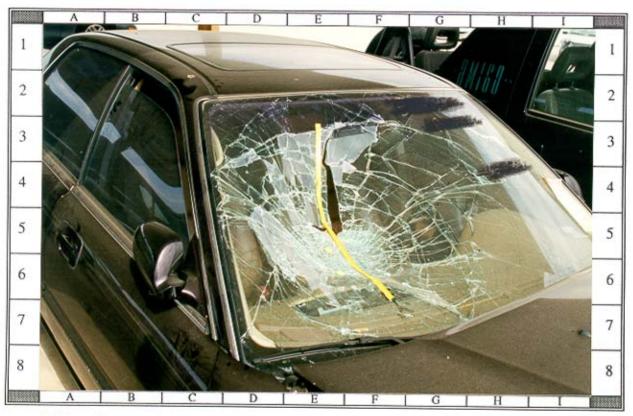
23 -- Case Vehicle's holed right windshield; NOTE: windshield holed from right front passenger's head contact

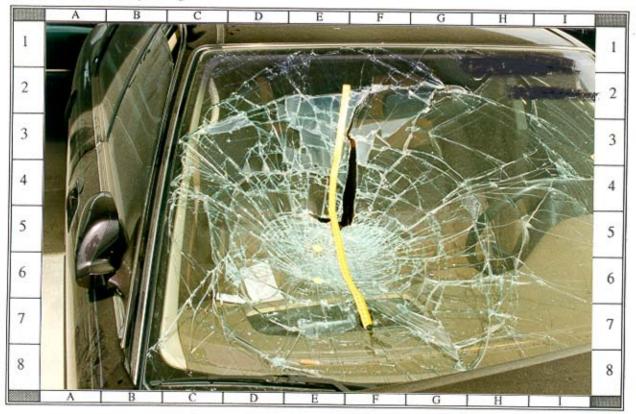
24 -- Close-up view of Case Vehicle's holed right windshield; NOTE: windshield holed from right front passenger's head contact

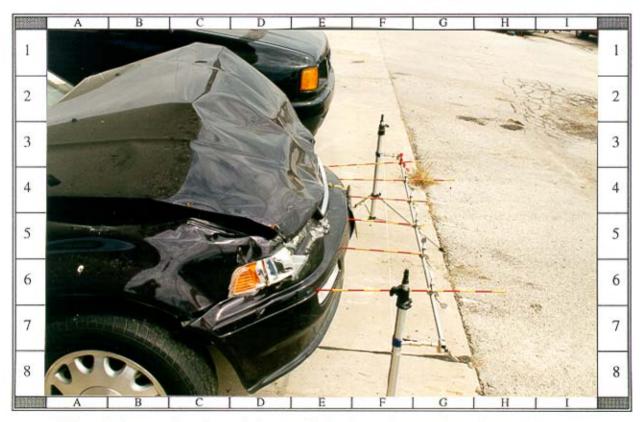
25 -- Reference line view of Case Vehicle's front damage from right with contour gauge present showing right front corner damage

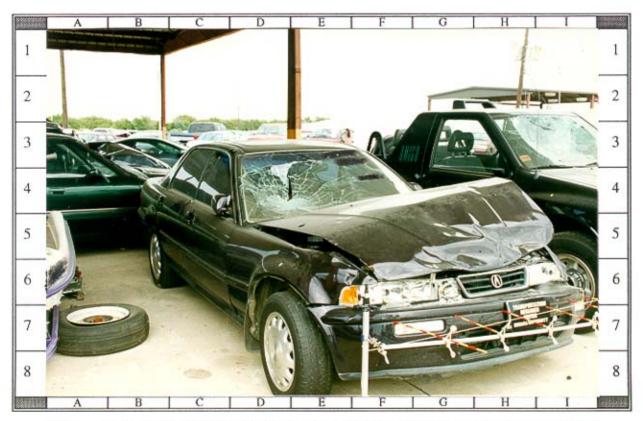
26 -- Reference line view of Case Vehicle's right side from front showing front right corner damage and slight leftward end shift

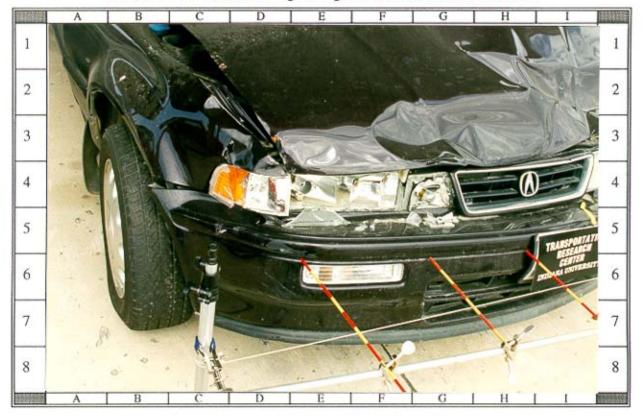
27 -- Case Vehicle's damaged front viewed from approximately 45 degrees right of front; NOTE: induced damage to right fender and holed windshield

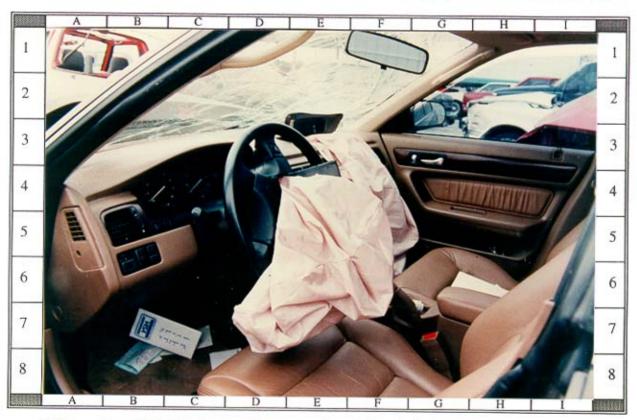
29 -- Case Vehicle's front seating areas viewed from left showing deployed driver and right front passenger air bags

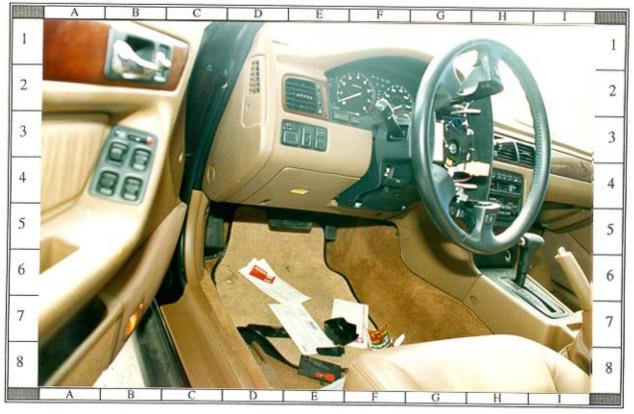
30 -- Interior surface of Case Vehicle's driver door and dash contacted by driver's left knee; NOTE: air bag removed from steering column hub

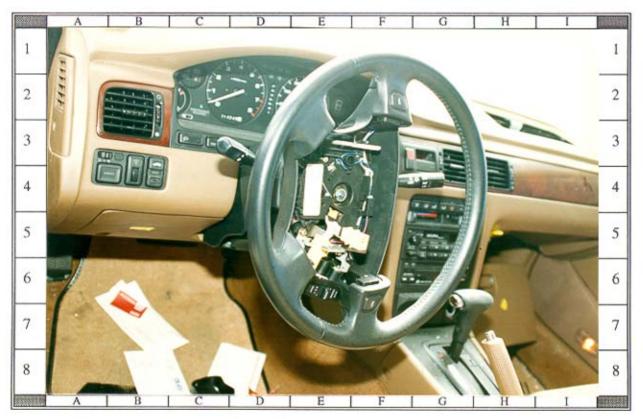
31 -- Close-up of Case Vehicle's left dash, instrument panel, and steering wheel hub; NOTE: removed driver's air bag

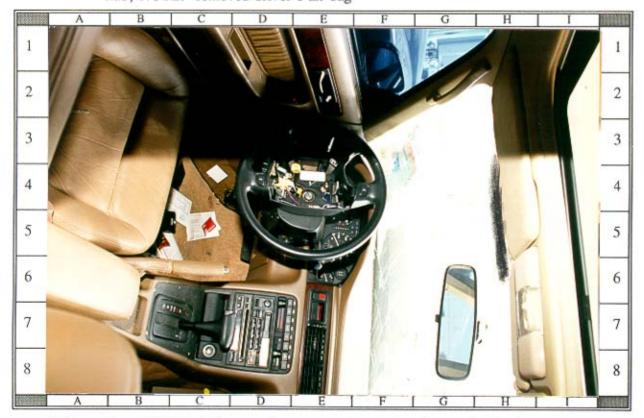
32 -- Case Vehicle's driver seating area, center dash and console, header, and rearview mirror viewed from center rear seat; NOTE: removed air bag

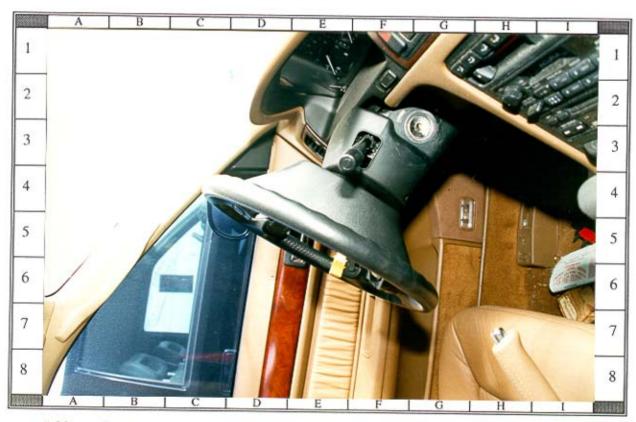
33 -- Case Vehicle's undeformed steering wheel rim viewed from right; NOTE: no evidence of contact to driver's door surface or left A-pillar

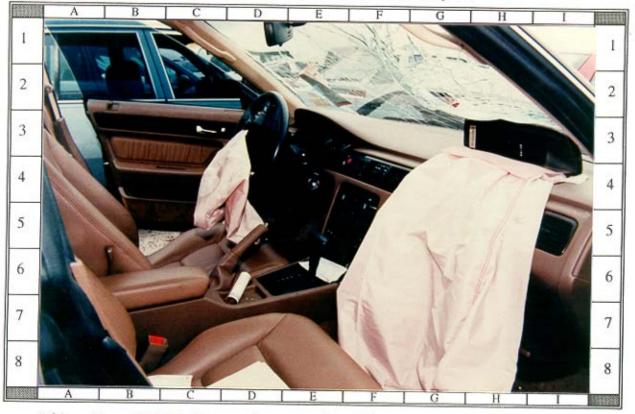
34 -- Case Vehicle's front seating areas viewed from left showing deployed driver and right front passenger air bags

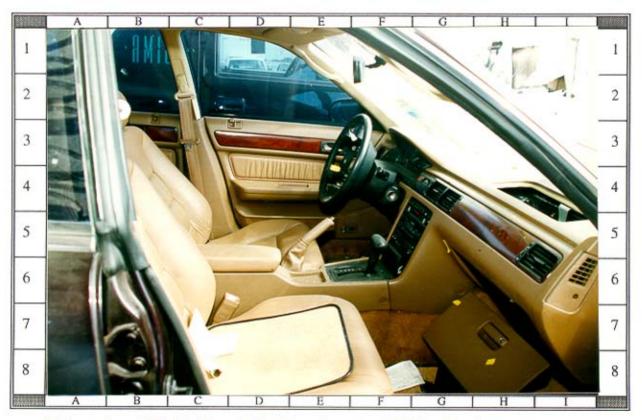
35 -- Case Vehicle's front dash and seating area; NOTE: right dash contacts, adjustable shoulder restraint, and removed right front air bag module

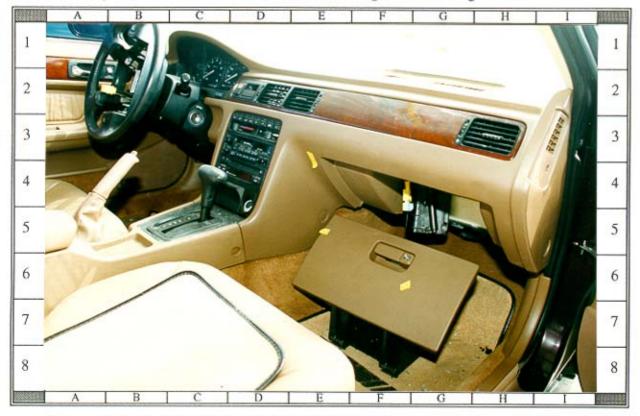
36 -- Case Vehicle's contacted right front knee bolster and glovebox; NOTE: yellow tape indicates contact areas

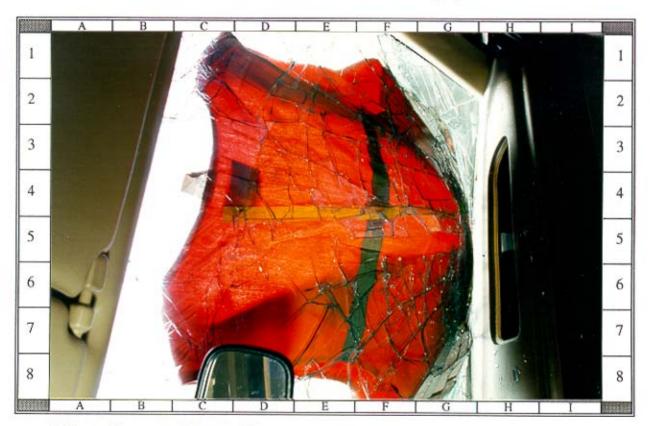
39 -- Close-up of Case Vehicle's holed right windshield; windshield holed by right front passenger's head

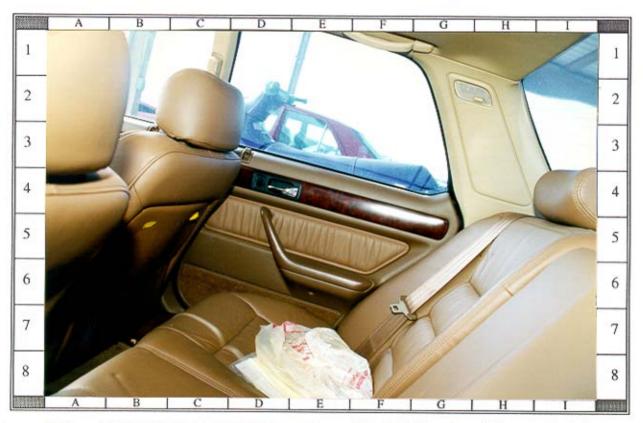
40 - Case Vehicle's rear seating area showing obvious contacts to right front seatback; NOTE: driver claims rear passenger was seated in position "21"

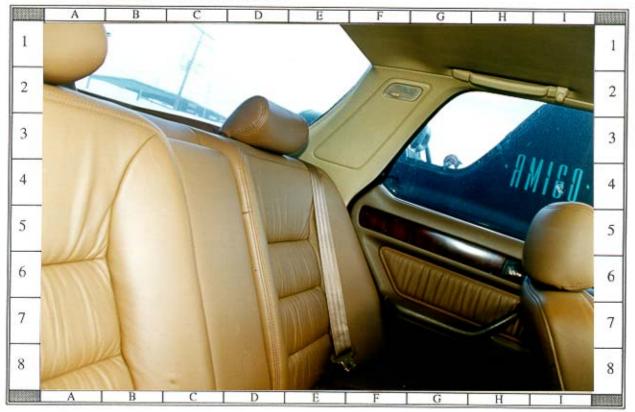
41 -- Case Vehicle's rear seating area from right; NOTE: outboard three-point belts and adjustable head restraints

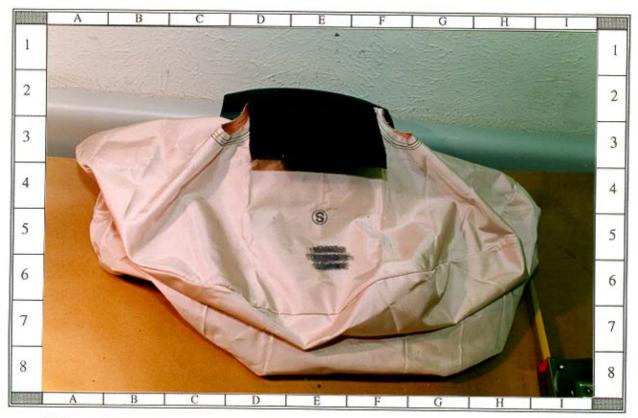
43 -- Case Vehicle's removed driver air bag with lipstick transfer ("P") from driver

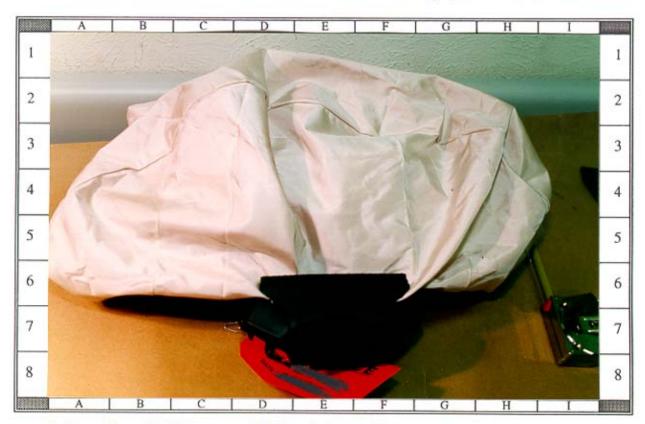
44 -- Case Vehicle's removed driver air bag and top cover flap; NOTE: no evidence of contact found

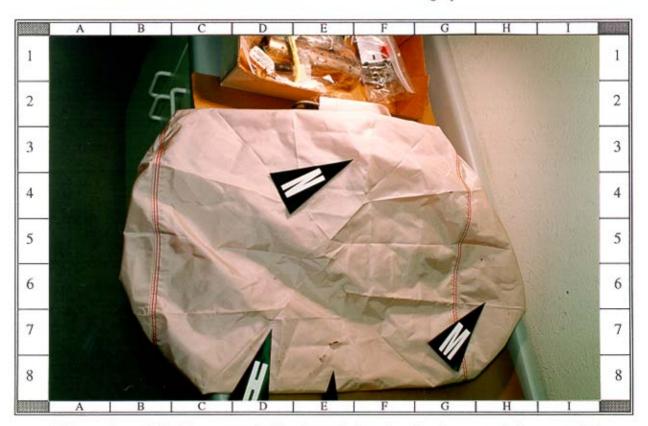
driver (mother) indicated that the sunglasses her daughter was wearing, were found on the roadway in front of the case vehicle at final rest. This passenger's right front air bag failed to fully because of an extensive tear the air bag sustained during the deployment. The tear to the air bag occurred during its deployment when the bag's material snagged the mounting screws on the inflator module; see SELECTED PHOTOGRAPHS #49 through #57. The air bag also sustained a few other cuts which were caused from the windshield glass.

47 -- Case Vehicle's removed right front air bag showing four cuts in bag material ("M","H","N", and "E") most likely from windshield glass

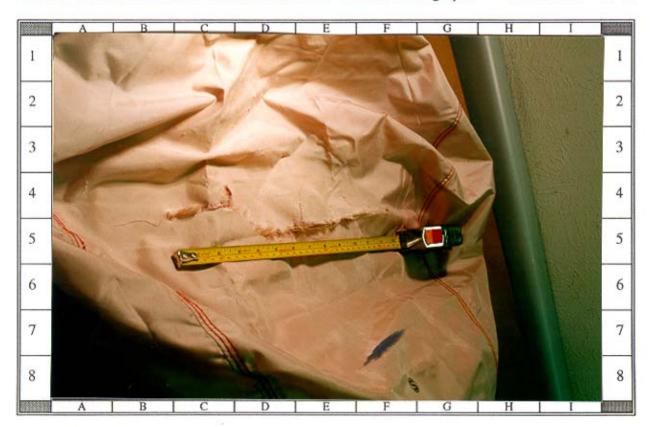
49 -- Case Vehicle's torn right front air bag; NOTE: tear located in bottom portion of air bag along fold lines

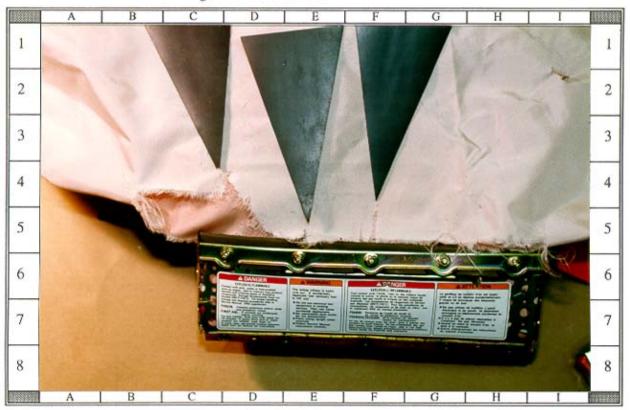
56 -- Case Vehicle's torn right front air bag showing that the tear marks originated from the screws on inflator module

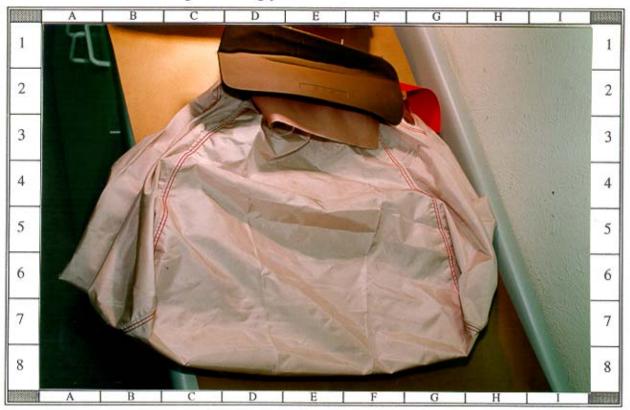
57 -- Case Vehicle's torn right front air bag showing that the origins of the tear occurred along the folding pattern lines

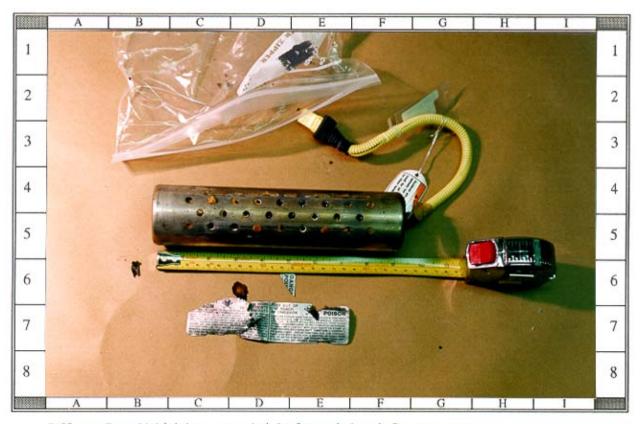
59 -- Case Vehicle's right front air bag showing 9 centimeter (3.5 inch) vent holes

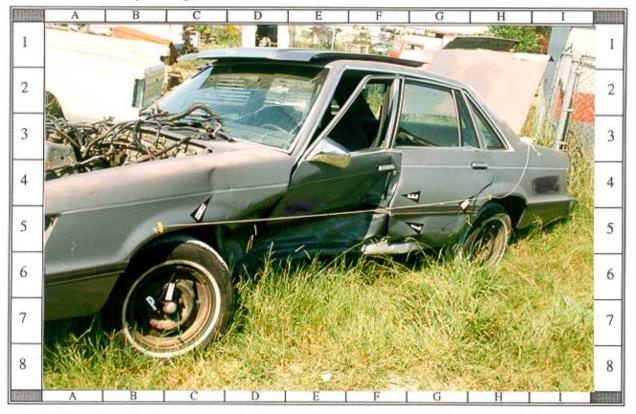
61 — Vehicle #2's undamaged front and damaged left side viewed from approximately 30 degrees left of front

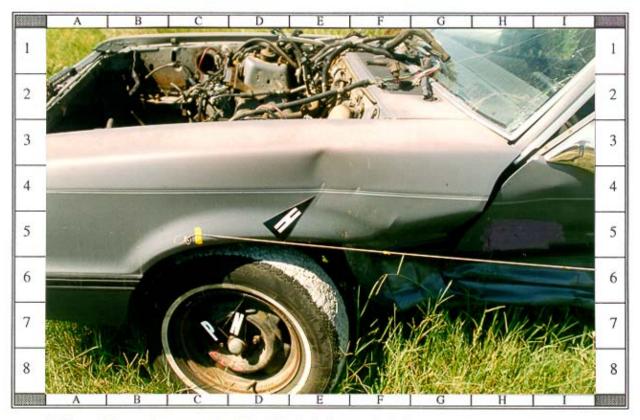
63 -- Direct damage to Vehicle #2's left front wheel rim ("N" and "P") and fender ("H") begins 17 centimeters (6.7 inches) behind axle

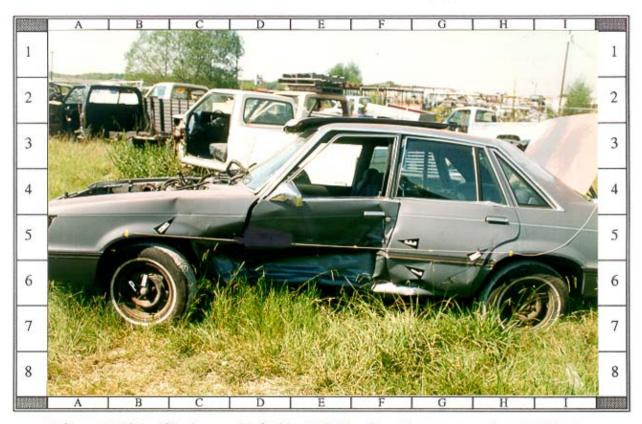
65 -- Vehicle #2's damaged left side; NOTE: direct damage goes from left front wheel rim ("P" and "N") rearward to B-pillar ("E" and "L")

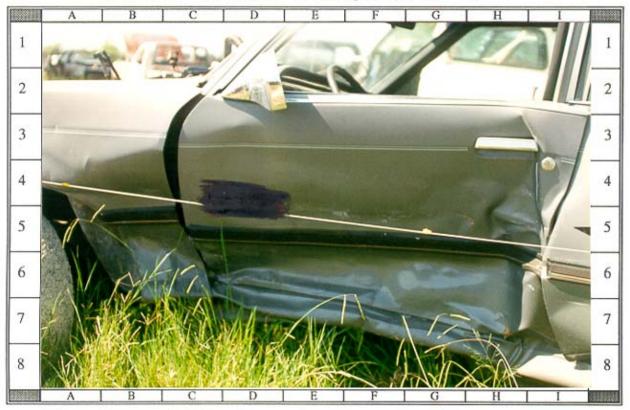
66 -- Close-up of Vehicle #2's area of maximum crush @ C₄ (see cells G5--G6); NOTE: tape on stringline represents location of crush measurements

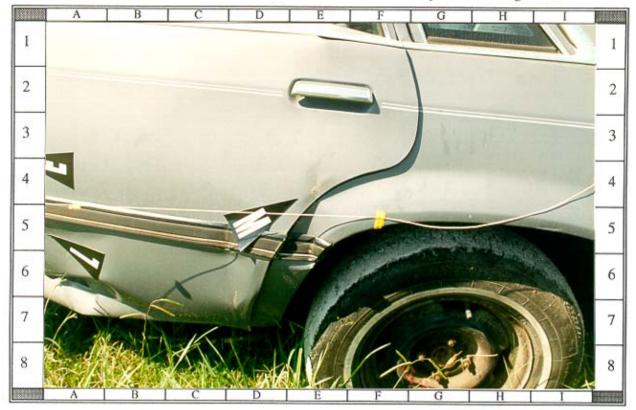
68 -- Close-up of Vehicle #2's spurious damage to left rear door area, possibly occurring in salvage yard

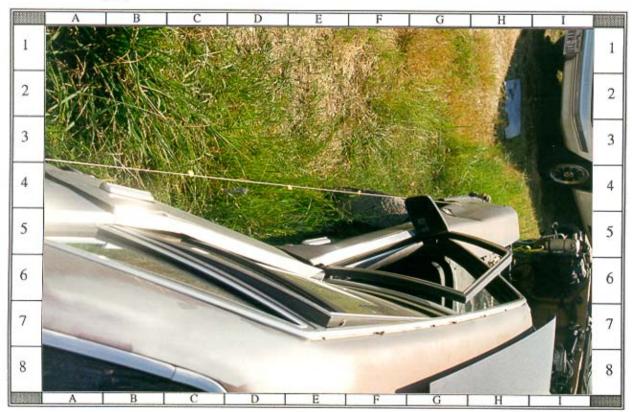
69 - Vehicle #2's damaged left side viewed from approximately 45 degrees left of back

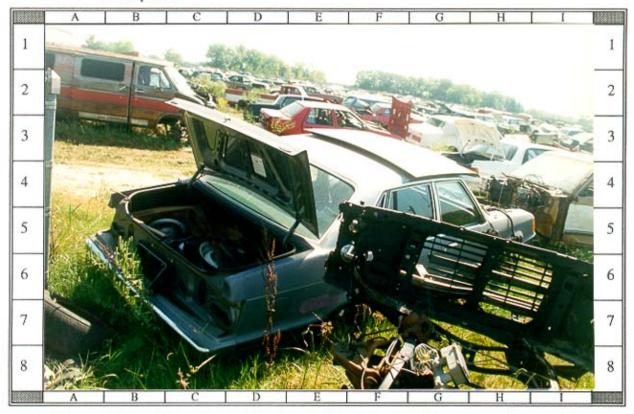
71 -- Reference line view of Vehicle #2's damaged left side from front showing crush profile

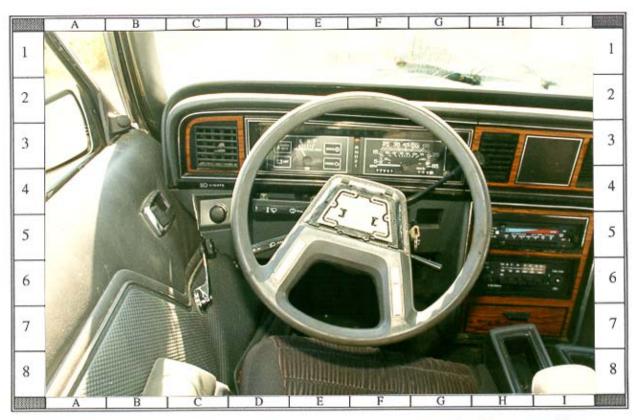
74 -- Vehicle #2's driver seating area, instrument panel, and dash view from outside driver window; NOTE: intrusion to driver's dash (see cells A3--B4)

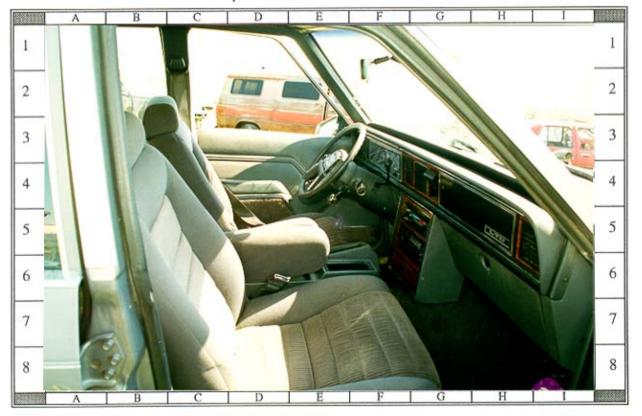
75 -- Close-up of Vehicle #2's driver seating area showing lack of contact evidence; NOTE: lower door panel intrusion

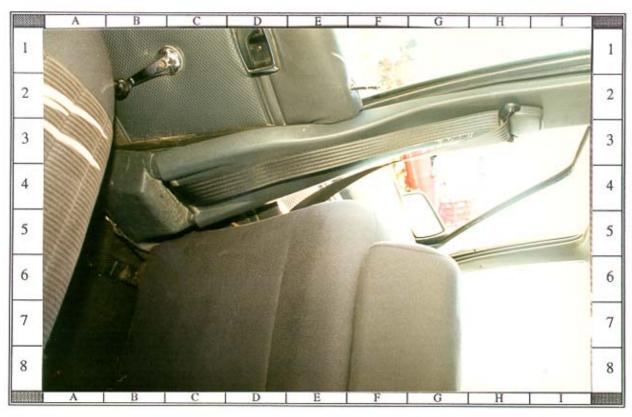
78 -- Close-up of Vehicle #2's left rear passenger door intrusion and deformed arm rest on door

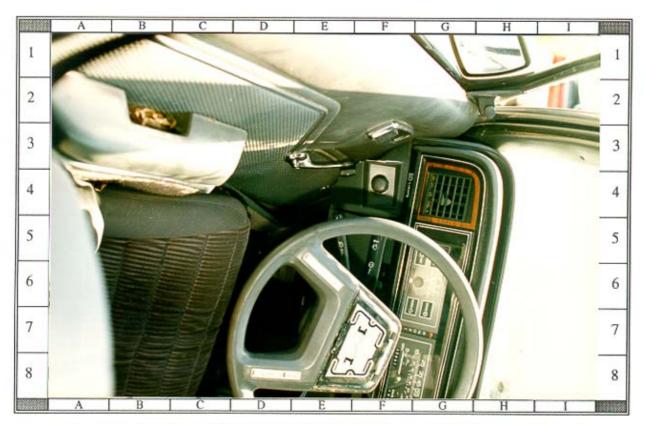
79 -- Close-up of intrusion to Vehicle #2's left B-pillar
